Technical Memorandum 33-733

*Single- and Dual-Carrier Microwave
Noise Abatement in The Deep Space Network*

JET PROPULSION LABORATORY
CALIFORNIA INSTITUTE OF TECHNOLOGY
PASADENA, CALIFORNIA

August 1, 1975

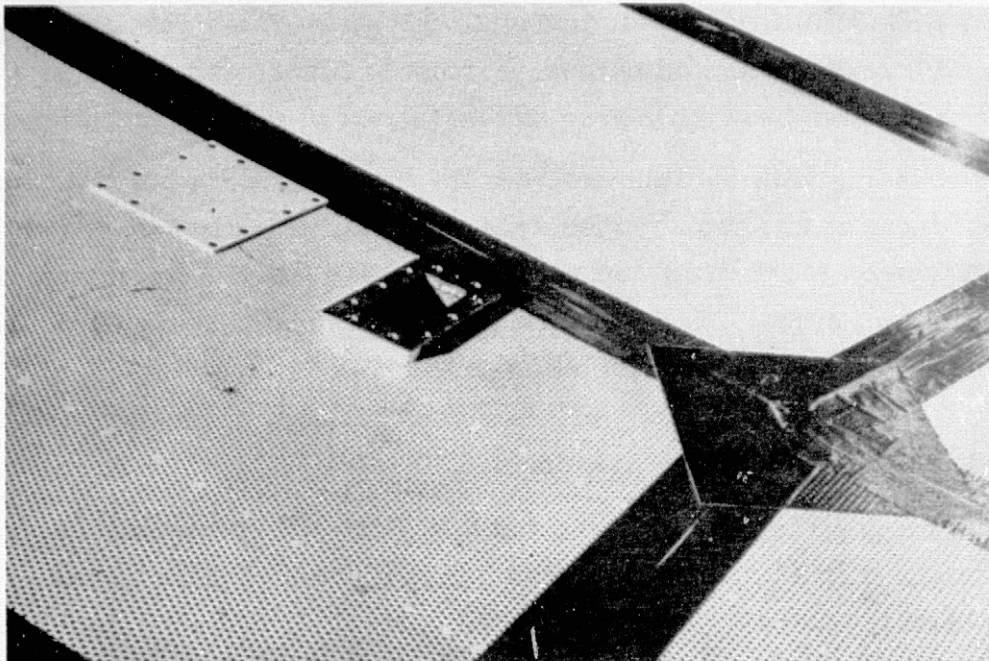
Figure 8. DSS 13 retaped main reflector and test probes

At this time (September, 1972), a substantial amount of questionably bonded hardware was removed from the exterior reflecting surfaces of the DSS 13 26-m antenna.¹¹ This hardware included the familiar conduits, lights, clamps, ladders, and other peripheral equipment. The reflecting surface was completely retaped with 100-mm-wide aluminum tape using newly available panel corner interface patches, as shown in Figure 8. Also shown in Figure 8 are the two surface test probes shown in the block diagram (Figure 6). One probe is broadband (waveguide bandwidth) while the other is a highpass filter, cutoff at 2200 MHz. With it, the receive band can be observed without simultaneously coupling in the strong transmitted signals near 2115 MHz.

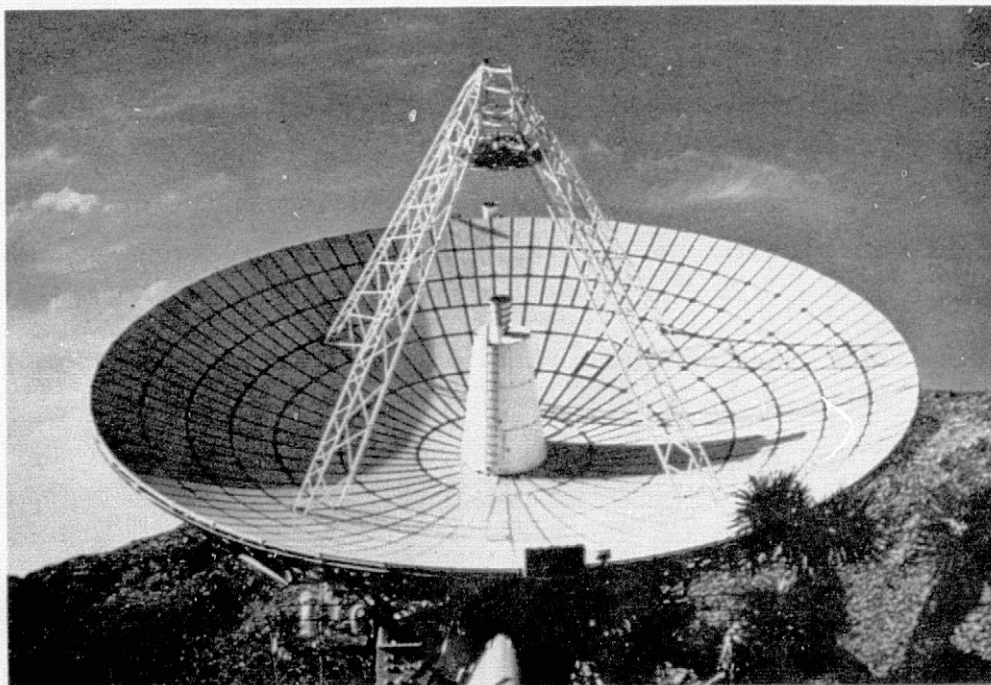
Figure 9. DSS 13 initial dual-carrier configuration

Figure 9 shows the DSS 13 antenna, as reconfigured in October 1972 for dual-carrier work. During the later stages of reconfiguration (prior to diplexer installation), tests of the transmitter output spectrum using a relocated water load were possible. Those data proved the 100-kW transmitter with dual-carrier excitation was operating properly and that transmit-band (low order) IMP was as anticipated from previous tests or better. In addition, the transmitter output at the receive band was checked for possible IMP. Under no conditions could receive band IMP be detected in the system using only a transmitter sampling coupler and water load elements. The tangential sensitivity of the instrumentation was -35 dBmW referred to the transmitter output port through use of the high-power waveguide directional coupler. After consideration is given for the 160 dB of microwave filtering to be used later, an excess of ~55 dB sensitivity was available to detect a receive band IMP of -140 dBmW, the then-prevailing interference level (at DSS 14).

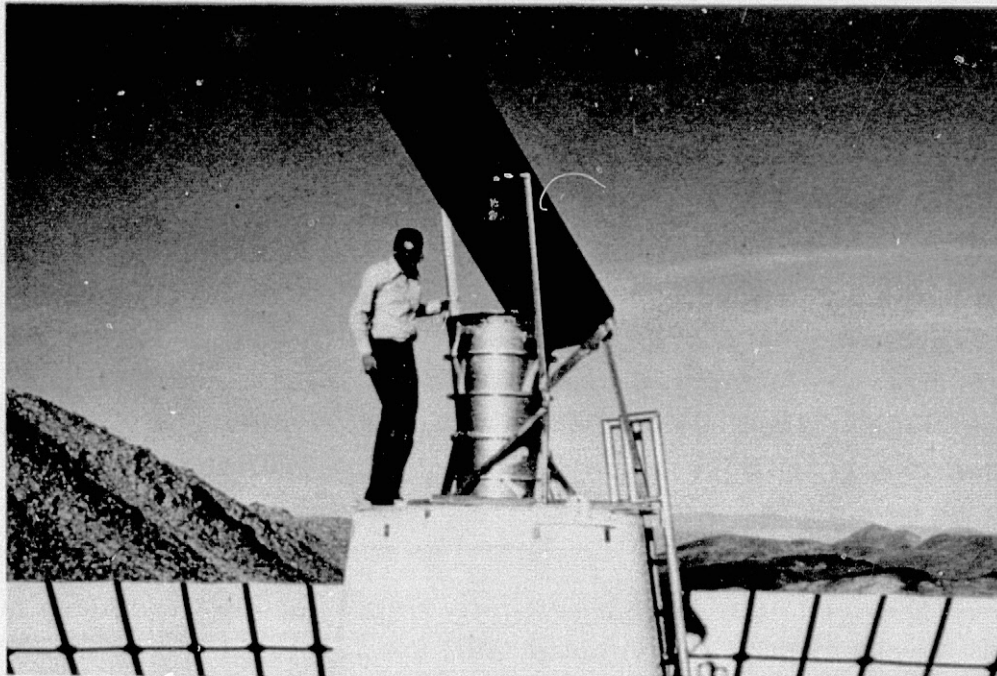
Figure 10. DSS 13 flat plate reflector on SRO feedcone

There were many questions as to whether the flat plate would be an effective switch (Figure 10) in providing high isolation from the antenna reflecting surfaces. Tertiary mechanisms, such as the previously mentioned support arm arcing, spillover, diffraction and others, might indeed support the observed intermodulation, in view of the tremendous dynamic range spanning uplink ($+76$ dBmW peak) and downlink (-135 dBmW average).

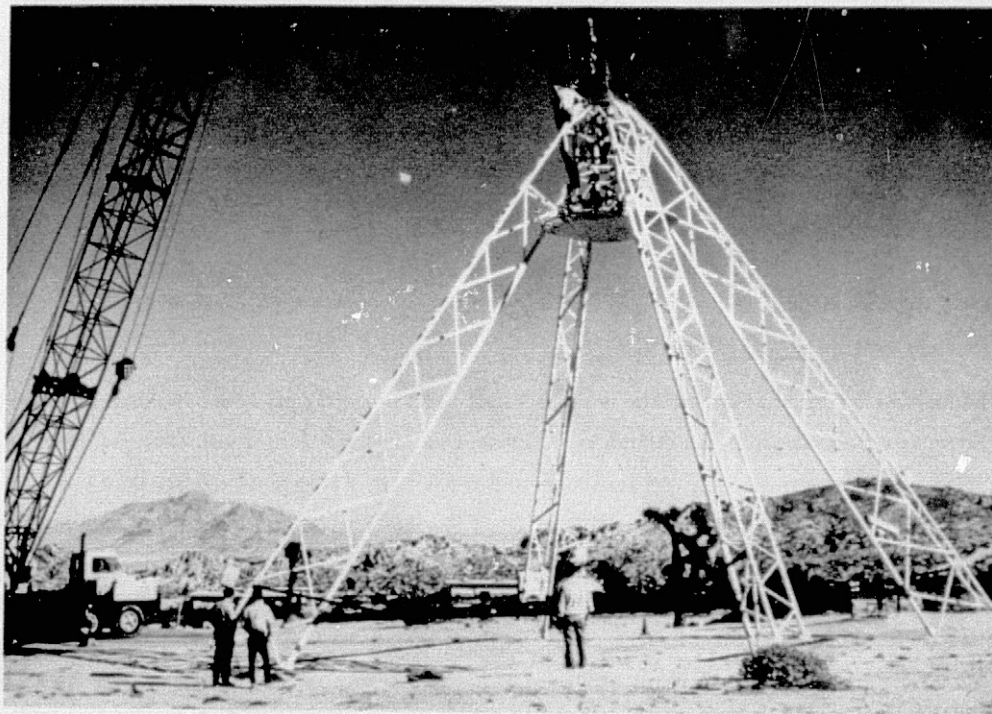
Figure 11. DSS 13 subreflector and quadripod removal

In order to provide a high-reliability answer to such questions, a more effective switch was employed. The subreflector and quadripod were removed as a unit (Figure 11), giving the feedhorn a clear field of view. Surprisingly,

performance with or without the quadripod/subreflector remained essentially the same, with the (not statistically significant) possibility that the mean level dropped 3 dB (-138 dBmW) after the quadripod removal. Samples of the receive system noise temperature, T_{op} , and receiver closed-loop automatic gain control (AGC) IMP instrumentation recordings made during this initial period are available in Figure 12.

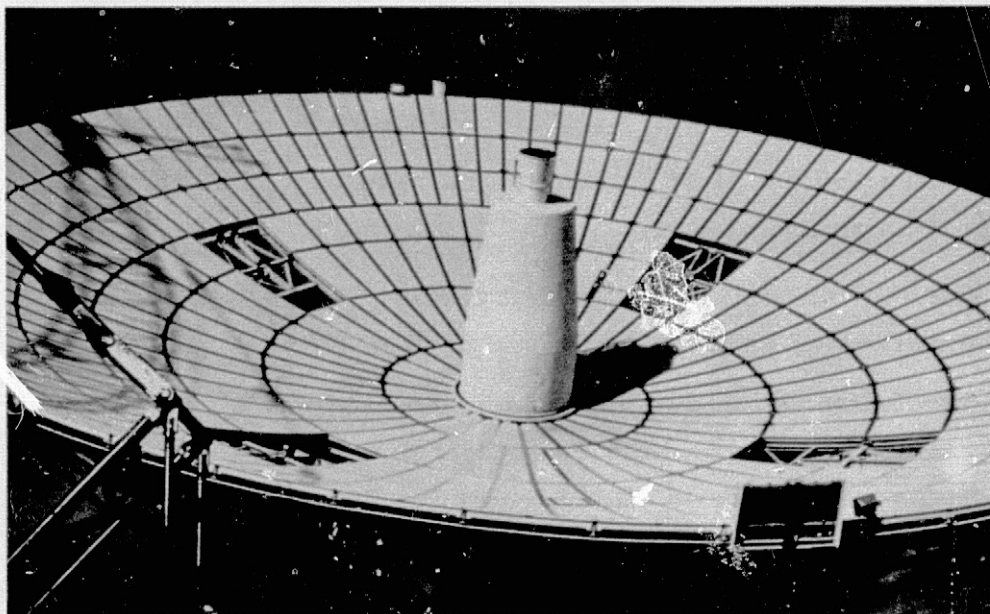
Figure 13. DSS 13 welded feedcone with SLH horn

Performance using the welded feedcone working into a clear field of view (Fig. 13) was as expected: NB less than 1 K, with IMP -172 ± 5 dBmW, for an extended test period including shock, vibration, solar illumination, and micro-phonics tests. The flat plate with all joints either welded or insulated was then tested with identical results. It should be noted, however, that such a flat plate test is a necessary but not sufficient test. Diffraction and spillover might still be possible problems after the quadripod/subreflector are installed. In view of the large dynamic range involved, the question still arose: What would the isolation of the flat plate reflector switch be with the quadripod in situ?

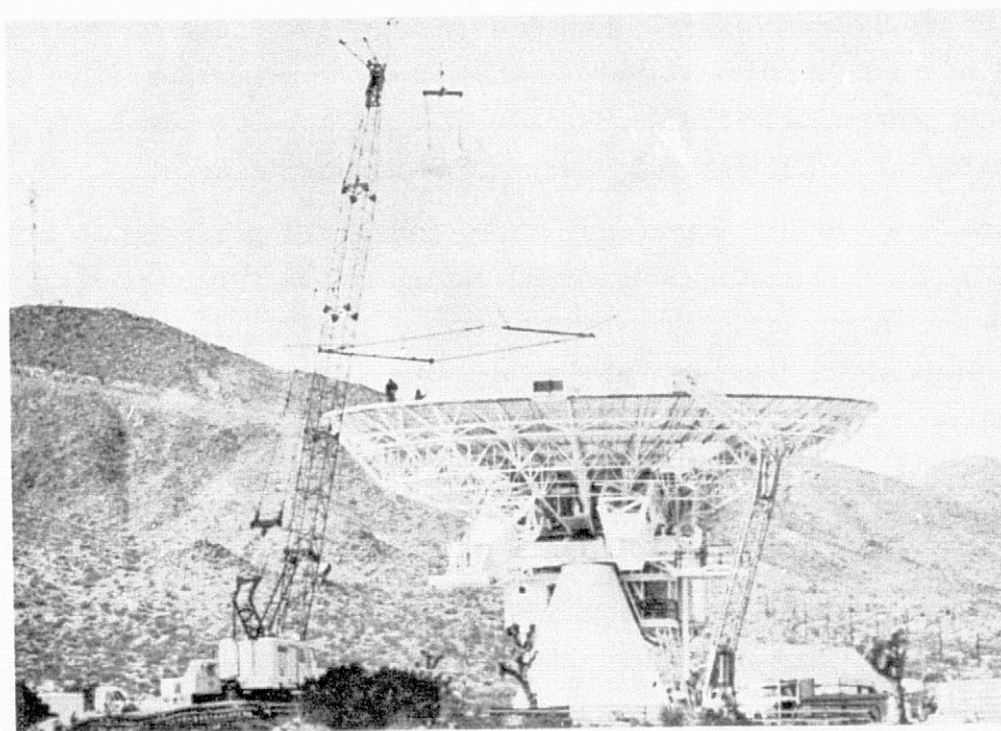
Figure 15. DSS 13 quadripod installation

After a high degree of confidence was obtained operating with the new feedcone, the quadripod was reinstalled (Figure 15). Questions requiring answers at this point were:

the bases of the quadripod legs and the feedcone base, using aluminum tape. Because of the physical complexity of these joints, many overlapping and/or wrinkled tape joints became evident on visual inspection, leading one observer to comment on the probability of overdoing otherwise good practice.

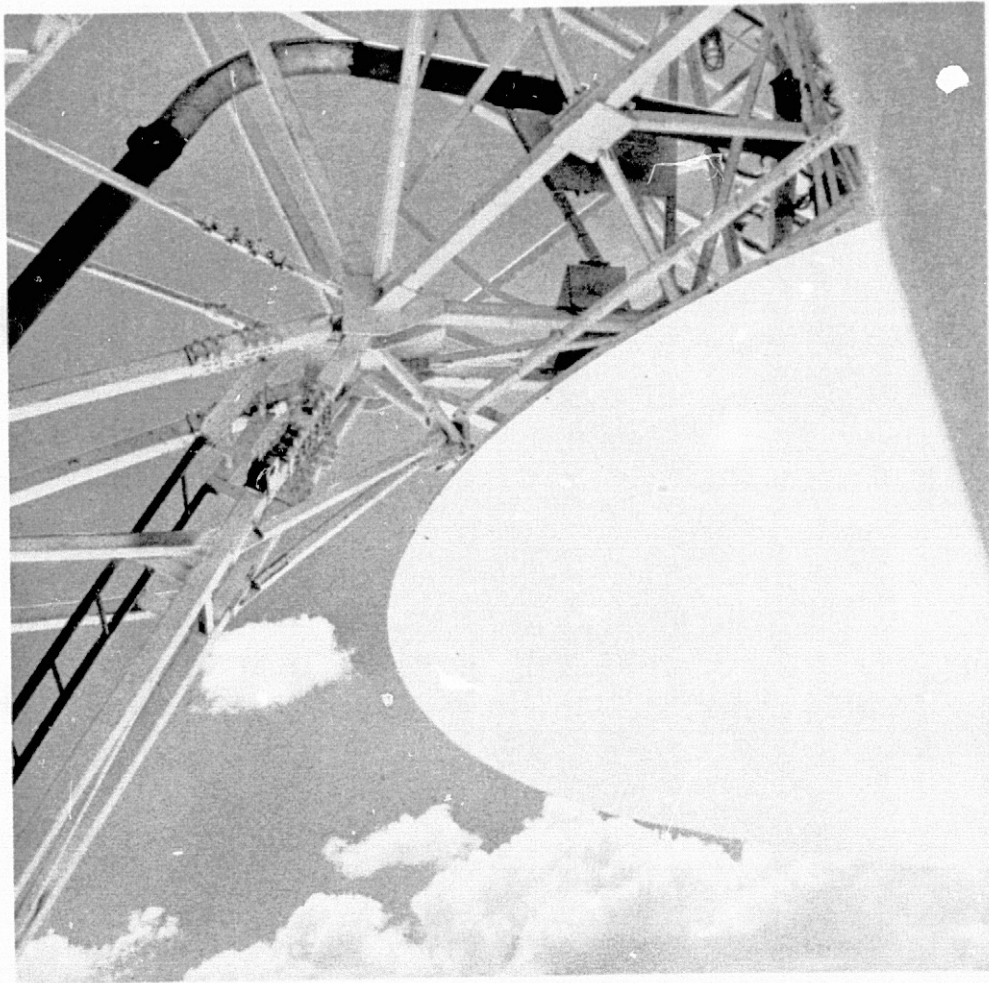
Figure 28. Subreflector shadow zone, DSS 14

diameter than the subreflector) (Figure 28). Electrical cables were rerouted. The A-frame subreflector hoist fixture was removed, to further reduce vibrations.

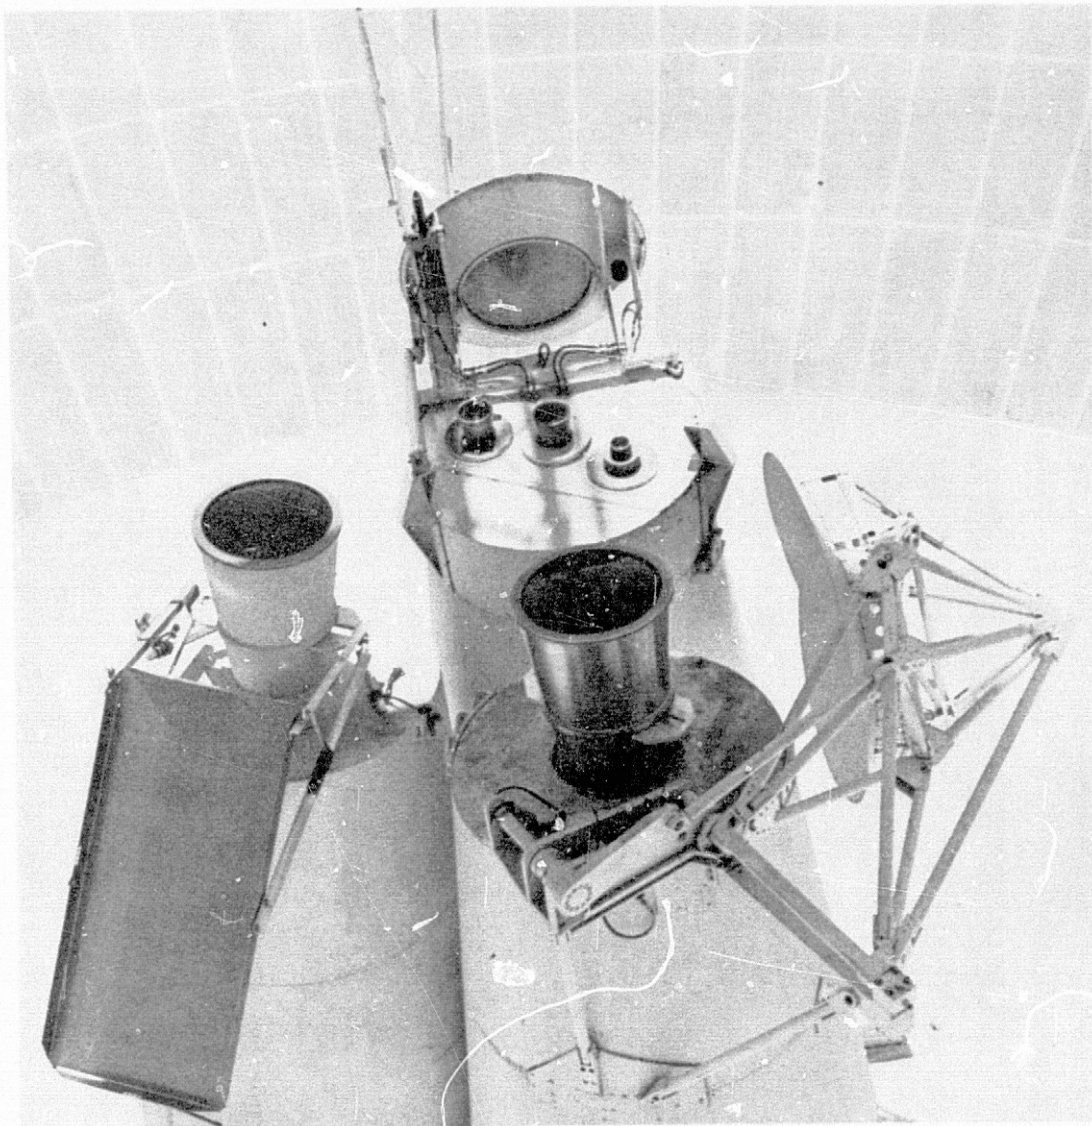
Figure 29. PDS, SMT, and MXK feedcone configuration, DSS 14

On the tricone assembly, all exterior seams of the PDS feedcone were welded. Existing ladders, walk rings, clamps, lugs, and handrails on the PDS feedcone were removed. An all-welded ladder was installed on the PDS feedcone. MXK and SMT feedcones were installed on the top of the tricone. These feedcones were both largely welded except for their newly installed prototype S/X feed hardware. This equipment consists of an ellipsoidal reflector atop the SMT feedcone and a dichroic plate over the MXK feedcone (both shown retracted in Figure 29.) The PDS feedcone is shown with a stowed flat plate reflector in Figure 29. It was expected that the S/X feed hardware, consisting of many bolted and riveted parts, hydraulic actuation mechanisms, electrical cabling, and limit switches, would prove to be a troublesome and difficult-to-correct source of noise interference. This expectation was confirmed by later tests. All feedhorn to feedcone roof interfaces were reworked as was necessary at DSS 13. Additional bolts were added, surfaces smoothed, and light grease applied as on a waveguide flange. Seams were welded on the upper portions of tricone surfaces. Hatch details and feedcone mounting rings on the tricone roof were welded (resultant welded seams have cracks and voids which could not be corrected during the noise abatement program). On the main reflector surface, the ground service hoist air motor was relocated beneath the reflector surface.

²⁹ An additional view is available in Section IV (Figure 29). In Figure 29, the frequency of bolting of the feedhorn to feedcone roof interface should be especially noted.

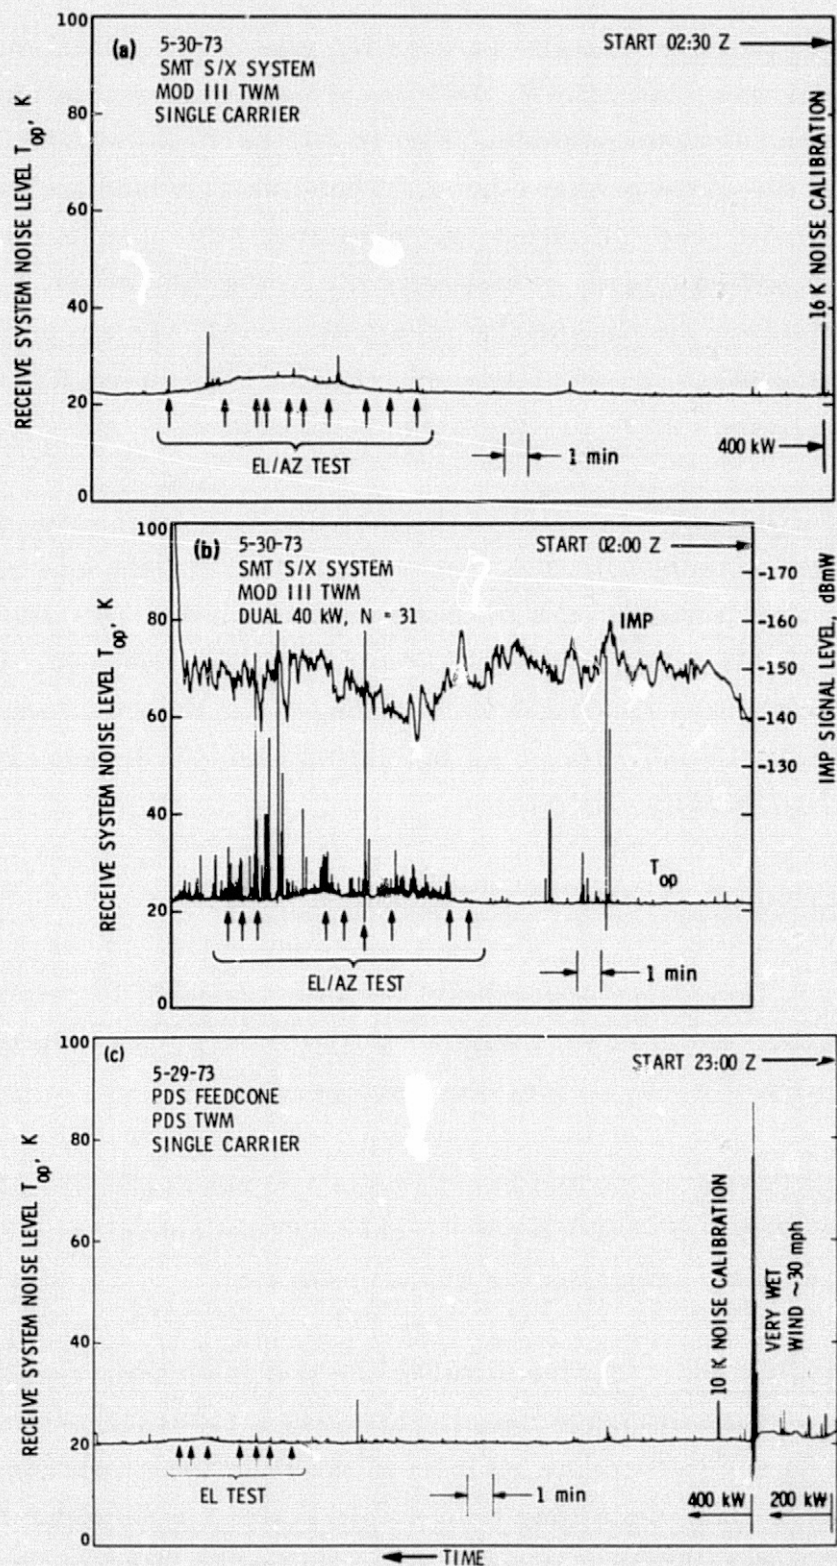
Figure 30. Representative DSS 14 noise and IMP performance (May 1973), (a) SMT feedcone with S/X optics, single carrier, (b) SMT feedcone with S/X optics, dual carrier, (c) PDS feedcone, single carrier

(2) Test Results. Single-carrier NB was 2-3 K. Dual-carrier NB was 10 K. IMP level was -150 dBmW. IMP level was more stable during structural excitation than in previous periods. Figure 30, parts (a) and (b), show the performance at the close of this period. These data, which include the prototype reflex/dichroic feed, illustrate the continued NB enhancement when operating with dual 40-kW carriers, compared with single 400-kW carrier. Figure 30 part (c) shows the essentially identical overall system performance duplexing with the other S-band feedcone. Each arrow in the figures represents a shock impact to the entire moving antenna structure, as mentioned earlier.

(3) Conclusions. In spite of the fact that two feedcones (MXK and SMT) were added to the antenna with their newly installed, high noise risk prototype S/X hardware, a significant improvement was achieved: 10-dB reduction in NB and IMP levels. The increased stability of the IMP suggests that very loose, poorly contacting hardware was no longer the major offender. The 10-dB factor might be interpreted as indicating that 90 percent of the initial problems had been finally abated.

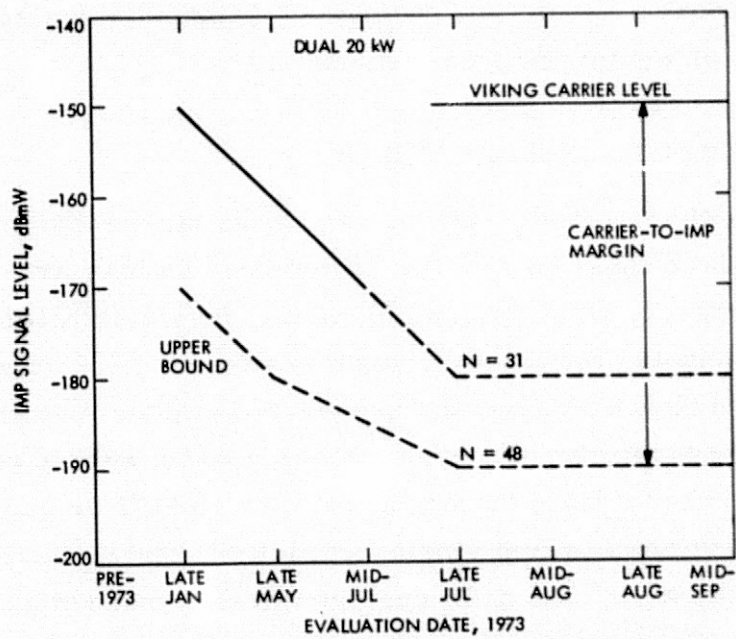
Figure 31. DSS 14 IMP performance for Viking (September 1973)

2. With the DSS 14 antenna and microwave equipment in the "as is" condition (as of September 1973), the dual-carrier performance at 20 kW was more than adequate to support the Viking application, as indicated in Figure 31. Note that the upper curve is taken from Figure 25 and that the worst-case Viking frequency separation offers additional margin over the nominal test conditions. Reservations are as stated in the preceding paragraph.

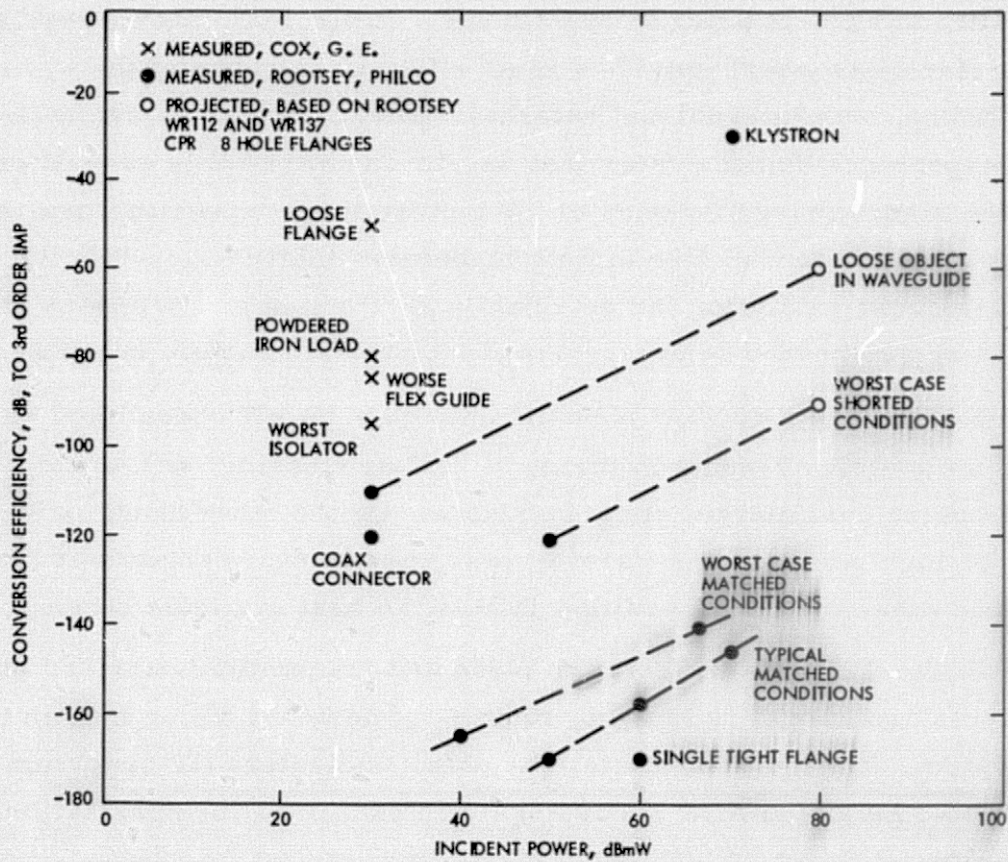
Figure 32. Third-order IMP generation

We are confident that detectable high-order intermodulation products do not originate within the normal transmitter system itself, at least for reasonably installed and maintained equipment. Low-order intermodulation, for example third-order IMP, is characteristic of DSN transmitter systems (Figure 32). Conversion efficiency in Figure 32 is simply power output (at the third-order IMP frequency) compared with power input (of one of the balanced fundamentals). Not surprisingly, a coaxial connector is at least 60-dB more efficient in generating third order intermodulation than a good waveguide flange. But because the DSN dual-carrier system combines the signals at the drive

level and throughputs the pair using a single klystron amplifier, low-order performance is dominated by the klystron.²³

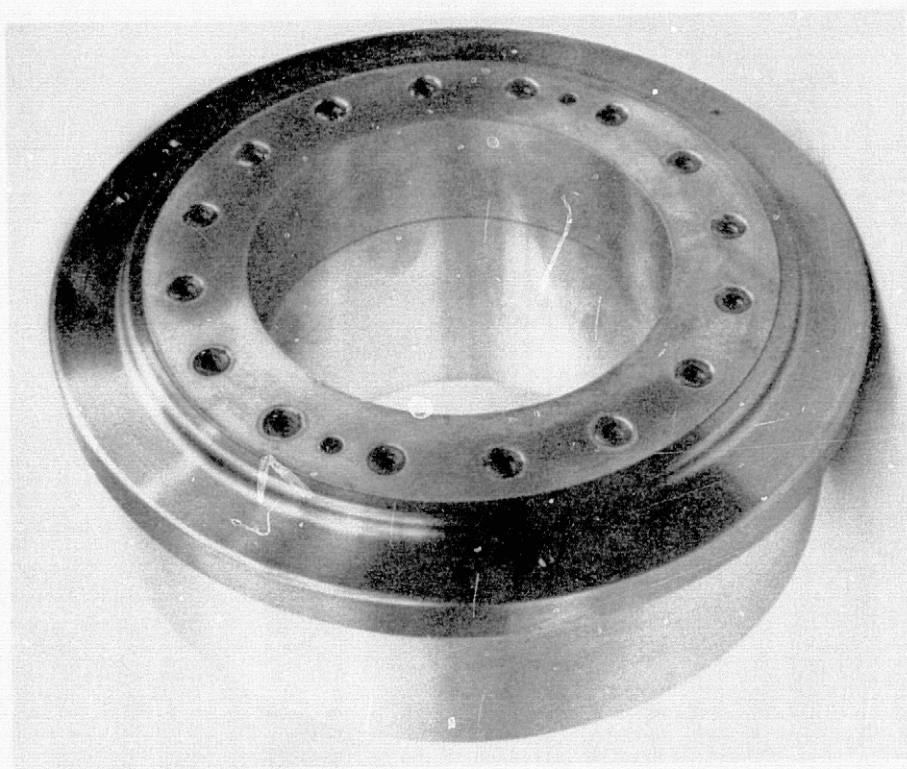
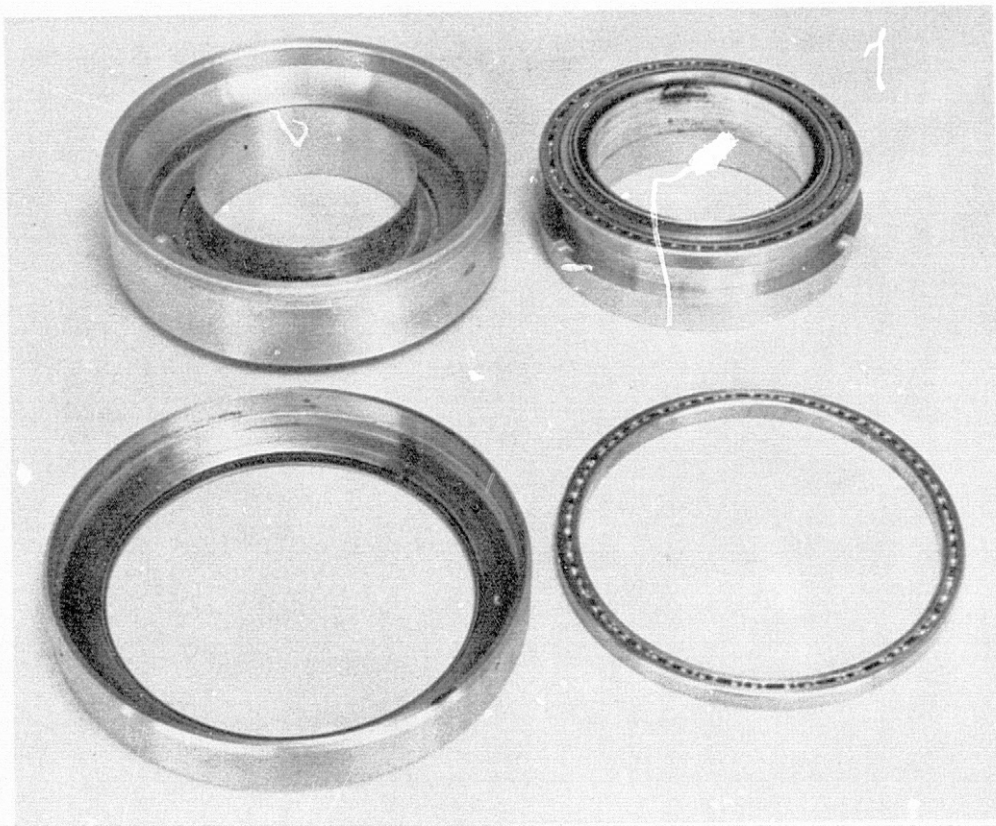
At DSS 14 one rotary joint in the PDS feedcone caused massive noise bursts (and occasional but not consistent transmitter high back power tripoffs) for a reason not observed at DSS 13. This component is shown assembled in Figure 37 and disassembled in Figure 38. A closeup (Figure 39) shows unmistakable arc pitting and metal galling. This damage was so extensive as to preclude a determination of whether a metal chip initiated the arcing, which then presumably contributed to the galling in the 0.25 mm choke gap. This event again demonstrates the extreme cleanliness needed in assembly of the waveguide system. Both remaining rotary joints in the PDS feedcone have operated without incident for approximately 5 years of heavy DSN and developmental radar service. Two units, returned from DSS 43, failed for a completely different reason. The initial assembly did not include proper bearing preload; thus the two sections of the rotary joint were free to wobble slightly and nearly contacted one another in the wrong regions. Light evidence of arc pitting was found.

Figure 37. Assembled S band rotary joint

Figure 38. Disassembled S-band rotary joint

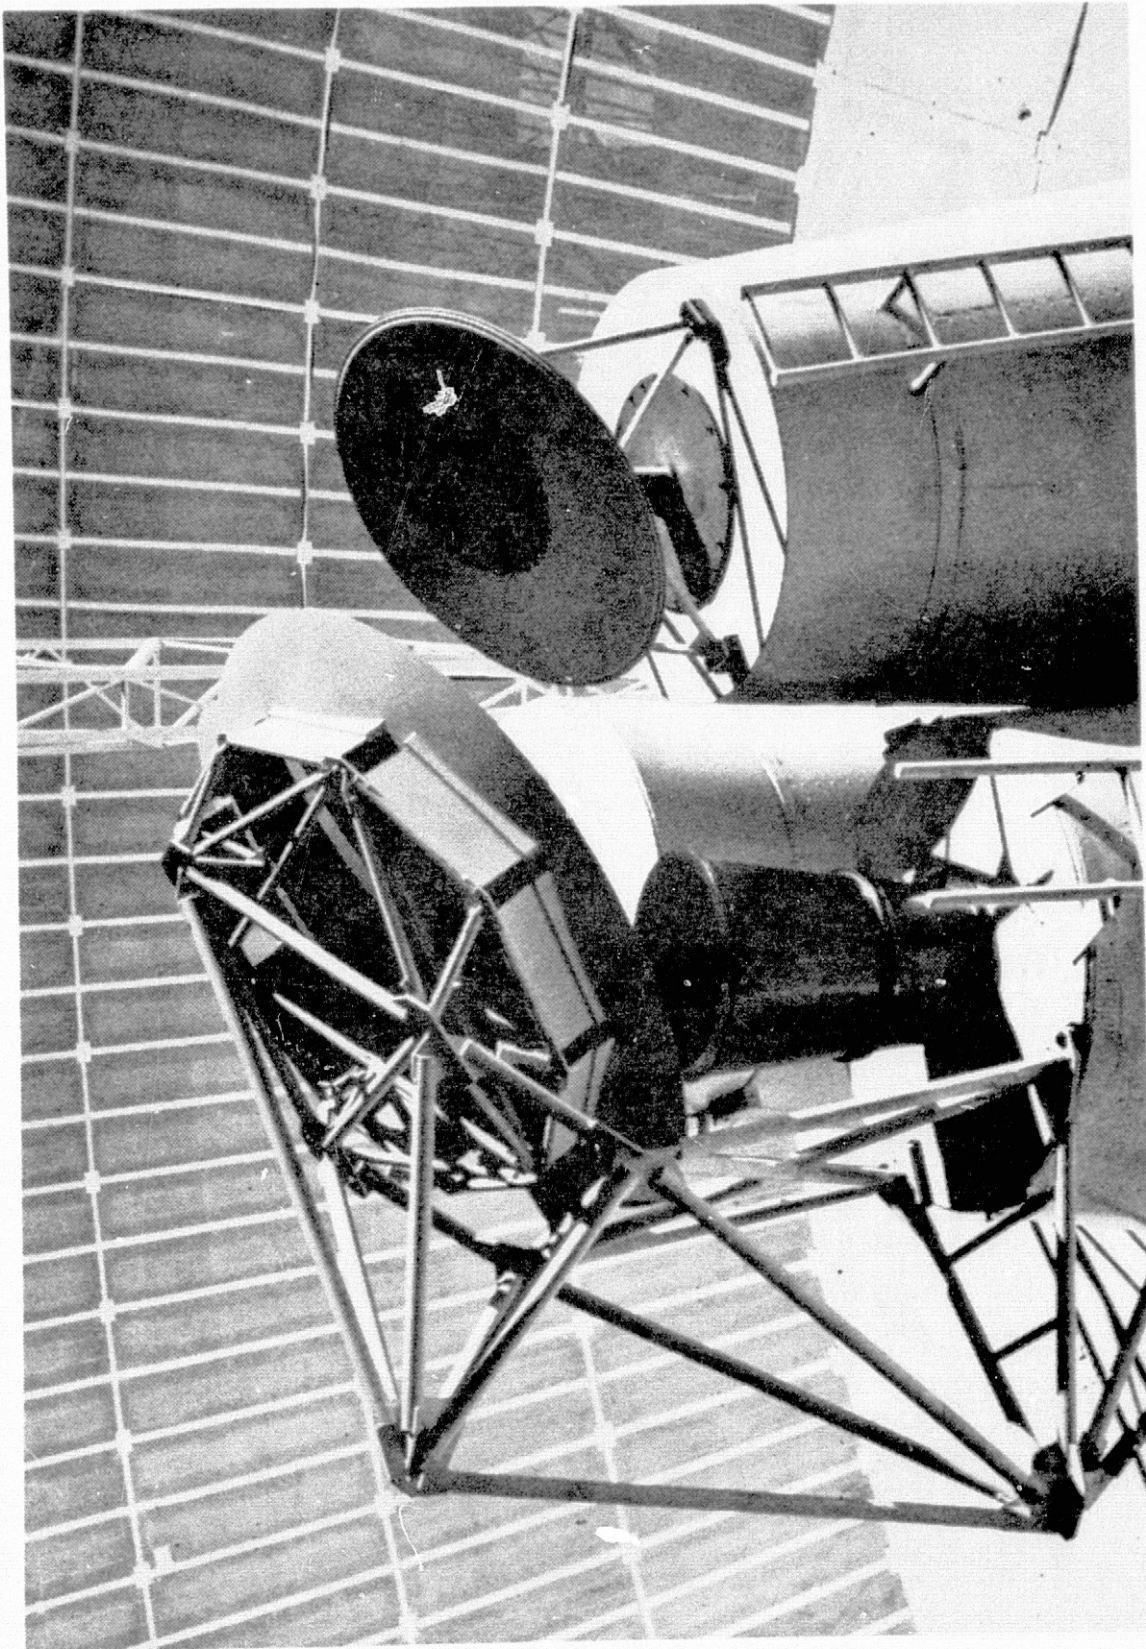
Figure A-7. Redesigned follow-on S/X feed at DSS 14

In Figure A-7, the dichroic plate is seen to be of single construction, despite slightly increased costs. Unfortunately, Figure A-7 illustrates some nonconformance with good practice. Although both feedcones shown are 100 percent

welded on the outside, the S-band horn mounting flange is not yet sufficiently bolted on a "5 bolts minimum per RF wavelength" basis. This feedcone system was constructed prior to full understanding of the necessity to thoroughly RF-bond this area and will require difficult and costly disassembly/rework. The X-band feedcone horn mounting flange in Figure A-7 is apparently also not sufficiently bolted; actually it rests on an 0.1-mm-thick insulator.
